# Manayunk as a Historic District

Mary Jo Rendon  
*University of Pennsylvania*

A THESIS

The Graduate Program in Historic Preservation

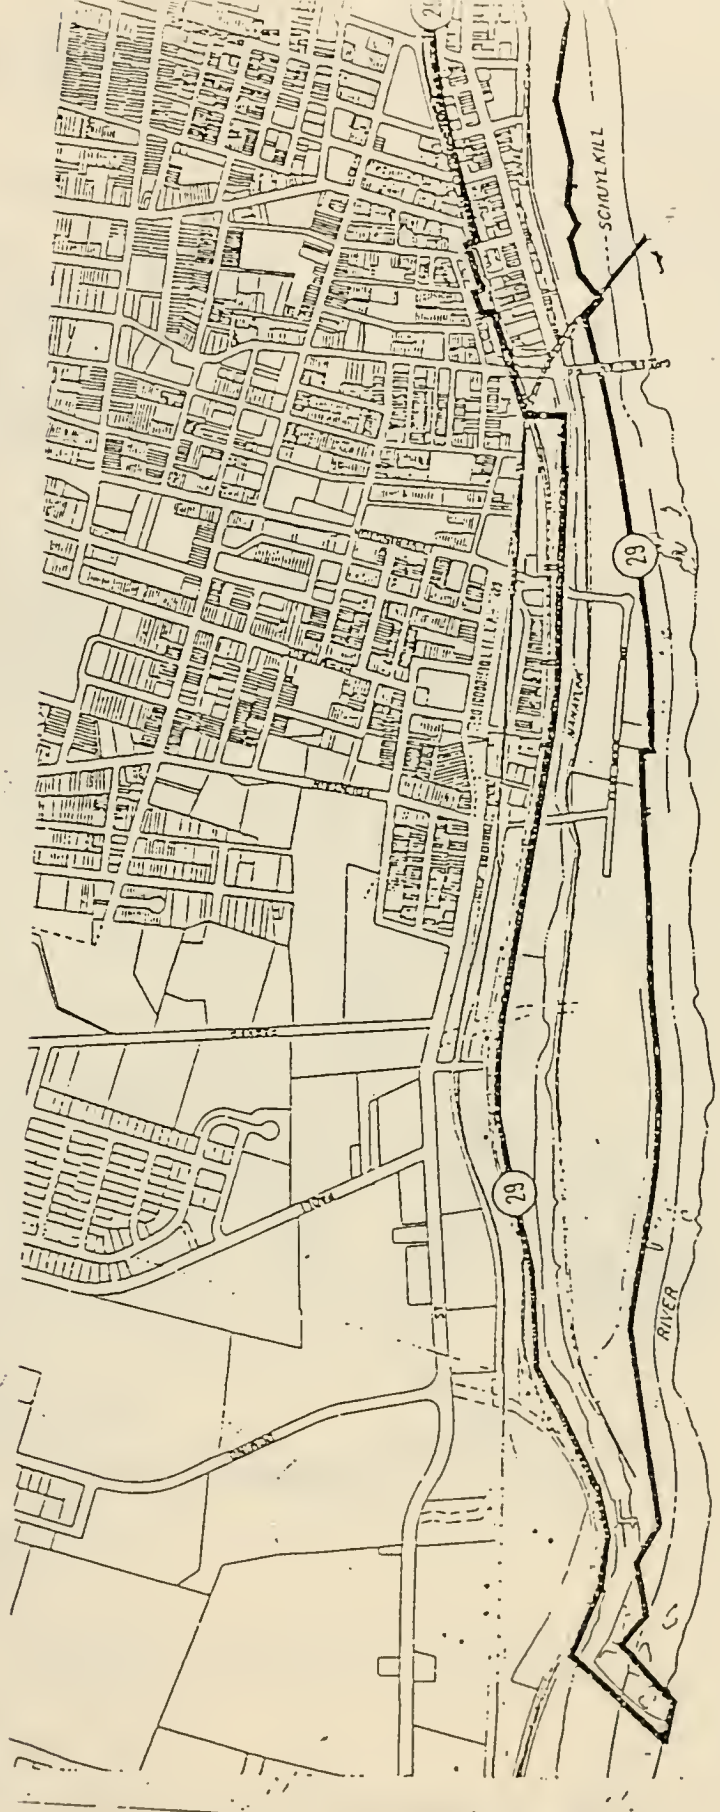
Illustration C- Manayunk's Main Street Historic District, 1973

This boundary continues to physically define Manayunk today. The historic district's borderline of Main Street creates a new edge. The district's boundary runs from Shurs Lane on the East, to Flat Rock Dam on the West; and the Schuylkill River on the South, to Cresson Avenue on the North. (see illustration C). Breaking the early boundary

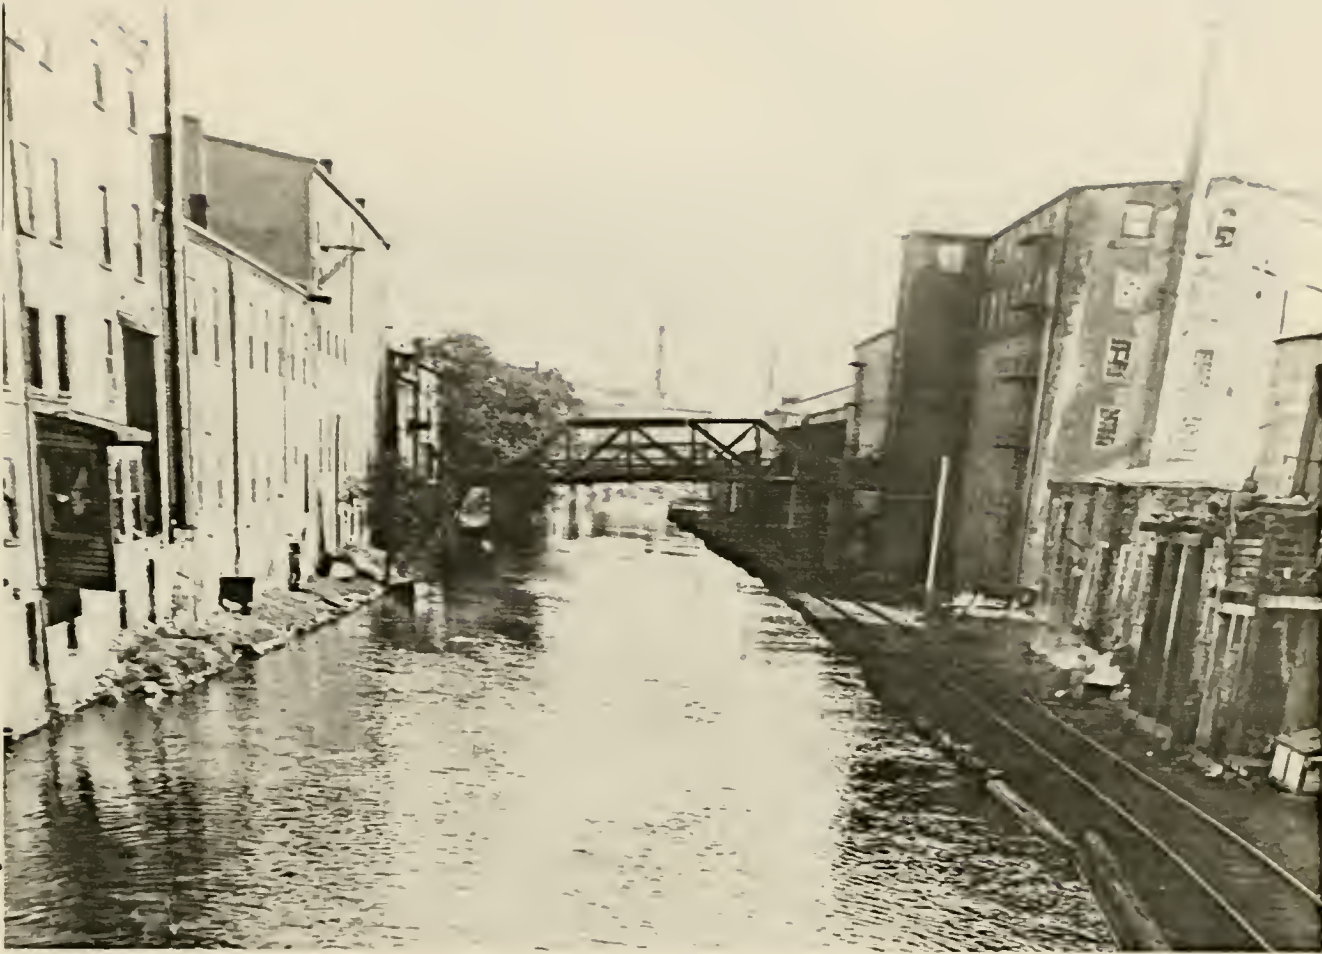
Illustration E - Manayunk Canal. Courtesy of the Pennsylvania Historical Society.

Construction of the canal provided good locations for mills to be erected. A strip of land situated between the canal and the Schuylkill River called Venice Island contained a substantial number of mills. These mills operated from the water power they received from both the river and canal. Bridges crossing the canal linked the mills with mill offices situated on Main Street. (see illustration E).

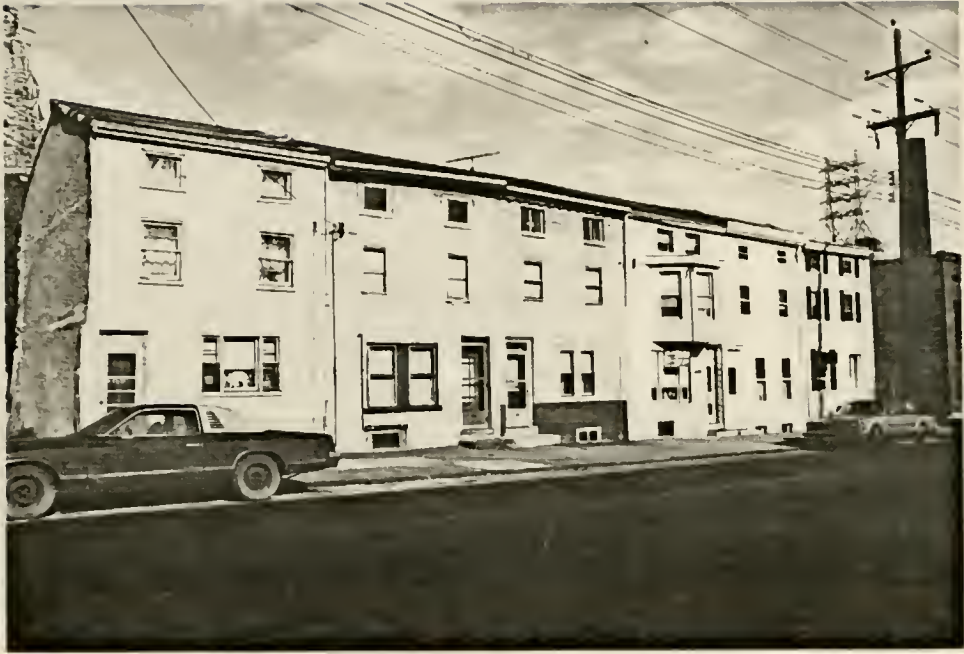
4105-4111 Row of Residences  
4113-15 Factory Structure

Circa 1850  
Circa 1860

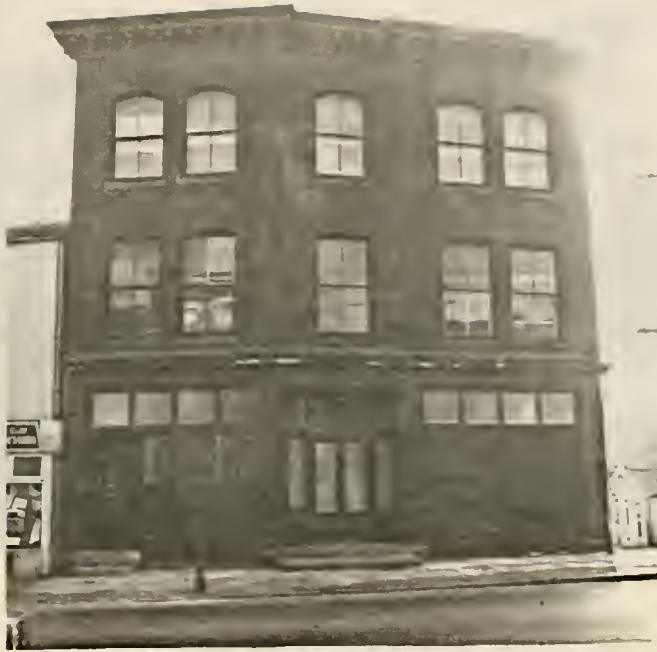
Circa 1860

produce chemicals. The same is true of 4236 Main Street which was originally the estate of Elizabeth Bolton in the 1860's. Seville Schofield, a manufacturer of yarns, purchased the building in 1866 and continued his business for thirty years. In 1915, the factory shifted its production to chemicals. The reason for this change is due to the fact that demand for chemicals, paper and soap was greater than that for textiles.
